JOINT TRANSPORTATION RESEARCH PROGRAM

INDIANA DEPARTMENT OF TRANSPORTATION
AND PURDUE UNIVERSITY

Evaluation of Sealers and Waterproofers for Extending the Life Cycle of Concrete

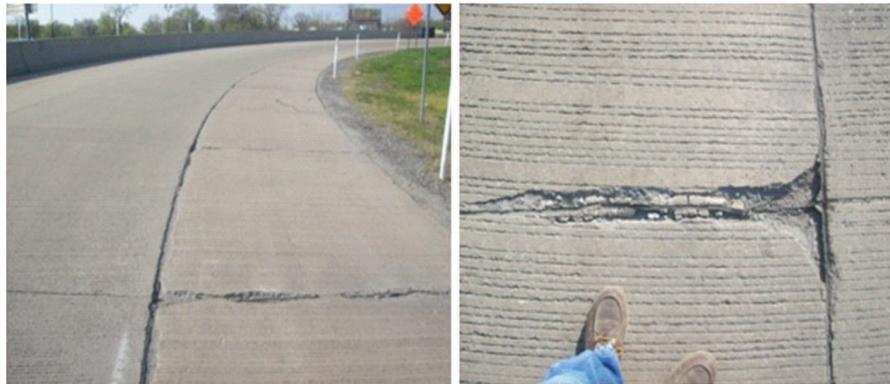
Figure 1.1 Field observation showing damage in pavement joints.

Figure 1.1 provides photographs showing the typical pavement joint damage that is being discussed in this report (Golias et al., 2012; Li, Pour-Ghaz, Castro, & Weiss, 2012). This type of damage is frequently seen as one of two types of damage. The first type of damage consists of small cracks that progressively spall off; these cracks are parallel to the saw-cut face at fractions of an inch from the saw-cut face. The second type of damage consists of the development of cracking parallel to the joint or spalling; the damage begins with a hollowed out region at the bottom of the saw cut,

resulting in a crack to the surface of pavement that is typically four to six inches from the edge of the joint. Unfortunately, damage is not frequently observed at the surface of the pavement until a significant amount of damage has occurred inside the joint. During field inspections it has been observed that where the joints are damaged, the sealant is damaged and the joint contains a significant amount of standing water (or fluid), as shown in Figure 1.2. The pavements in Figure 1.2 were examined in 2005. The material in the pavement exhibited a complete destruction of the matrix while the aggregate remained intact. It should be noted that it had not rained for nearly two weeks; however, fluid was standing in the joint. It is important to note that while this damage is more likely to occur in pavements with poor air entrainment, damage occurs in both poorly air entrained and properly air entrained concrete.

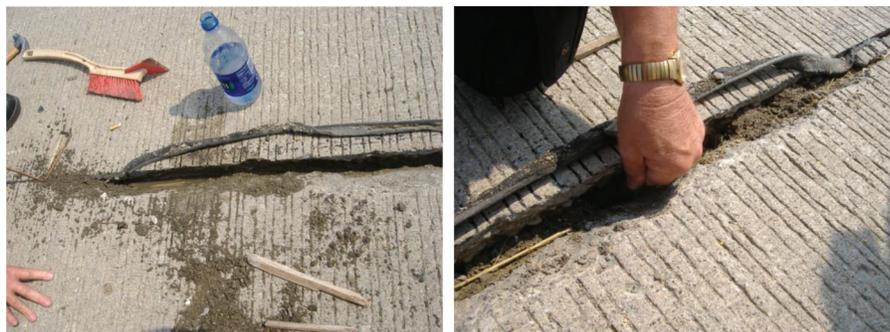
Figure 1.2 Field observation showing damage in pavement joints containing water.

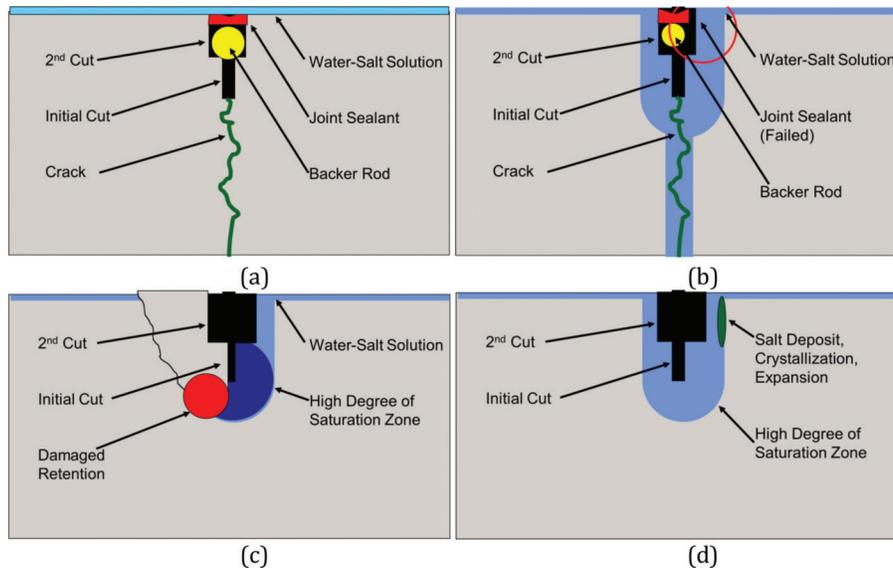
Figure 1.3 Potential degradation hypothesis: (a) an ideal joint, (b) a joint with damaged joint sealant that is cracked, (c) a joint with damaged joint sealant that is uncracked, and (d) a joint illustrating potential salt crystallization locations.

Figure 1.3 illustrates a proposed series of mechanisms that appear to be partially responsible for this damage (Weiss & Nantung, 2007). In Figure 1.3, a 1-D construction joint is illustrated that is typical of that used by the Indiana DOT. The joint is created by saw-cutting the pavement shortly after placement with a single cut that is approximately 1/3 the depth of the pavement. The intention of this saw-cut is to provide stress relief, which can allow cracks to form at these locations. A previous report provided details on how to best place and time these saw-cuts to minimize the potential for random cracking (Raoufi, Weiss, &

Nantung, 2008). The pavement would then be expected to crack at the joint (though this crack does not always occur, as explained in the following paragraphs). After several days (to weeks) the saw cut is cut again to widen the cut, which provides a notch at the top of the joint for the placement of backer rod and a joint sealant. This second cut also allows minor raveling to be removed and attempts to provide a more uniform joint width since some of the opening has already occurred. The joints are then cleaned, dried, and a non-absorptive backer rod is placed in the joint and a joint sealant is then placed. If ideal, this constructed sealed joint will keep water and deicing salt out of joints; however, invariably the sealer pulls away from one of the walls or cracks as shown in Figure 1.3 (b). It is proposed that this allows water and deicing salt to enter the joint and be absorbed by the faces of the saw cut. While the fluid enters the hollow section created by the saw-cuts, the fluid likely drains through the crack at the base of the saw cut into the open graded base. This will increase the degree of saturation along the walls of the saw-cut and along the walls of the crack. This changes dramatically, however, it will not occur if the crack does not form below the saw-cut (as shown in Figure 1.3 (c)). Without a crack, the fluid pools in the joint is absorbed by the concrete and becomes increasingly concentrated (with respect to deicing salt) over time. This can develop a zone with a high degree of saturation. This high level of saturation can result in freezing damage and/or in chemical reaction in some systems (e.g., the formation of Friedel salt that can infill air voids (Arribas-Colón et al., 2012; Bu & Weiss, 2014; Farnam, Bentz, Hampton, & Weiss, 2014; Farnam, Bentz, Sakulich, Flynn, & Weiss, 2014; Farnam, Wiese, Bentz, Davis, & Weiss, 2015; Jain et al., 2011; Jitendra et al., 2012; Olek et al., 2007; Radliński et al., 2008; Radliński et al., 2010), the production of oxychloride (Farnam,

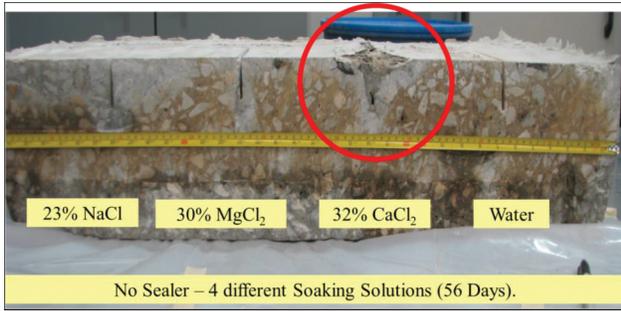
Figure 1.4 Damage development due to drying and wetting with deicing salts.

For example, Figure 1.4 illustrates the behavior of salts under only drying and wetting and it can be noticed that even in cases where freezing may not be occurring, damage can develop at the joint. At the current time this appears to be consistent with salt crystallization during drying and wetting however this mechanism has not been studied in great detail for pavement joints.

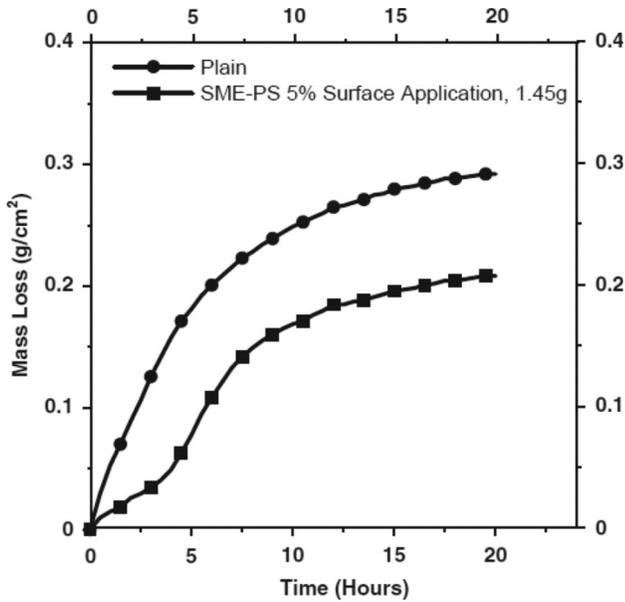
Figure 2.1 Evaporation of water over time in plain sample and sample topically treated with SME-PS.

Drying shrinkage tests were also performed on plain samples as well as samples with SME-PS with 1% and 20% polystyrene. It was observed that upon drying, the treated samples had less mass loss. The sample with 1% PS had a mass loss roughly 10% less than the plain sample. It was also observed that there was no substantial effect (either positive or negative) on shrinkage (Coates et al., 2009).

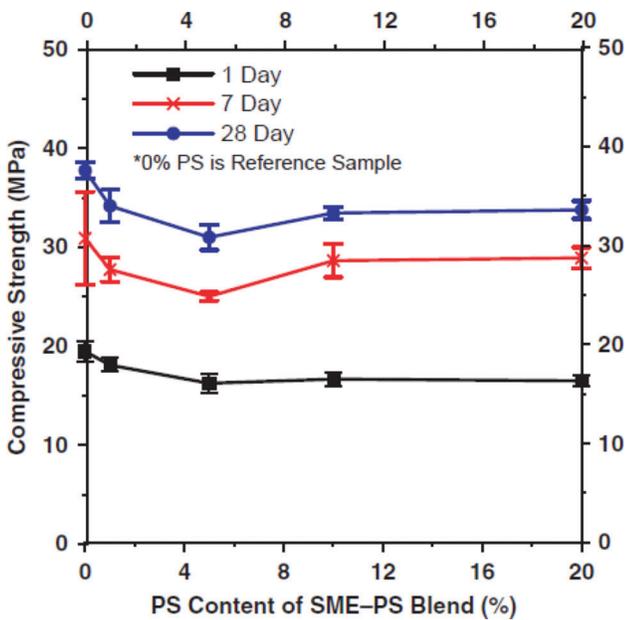
Figure 2.2 Compressive strength versus polystyrene content.

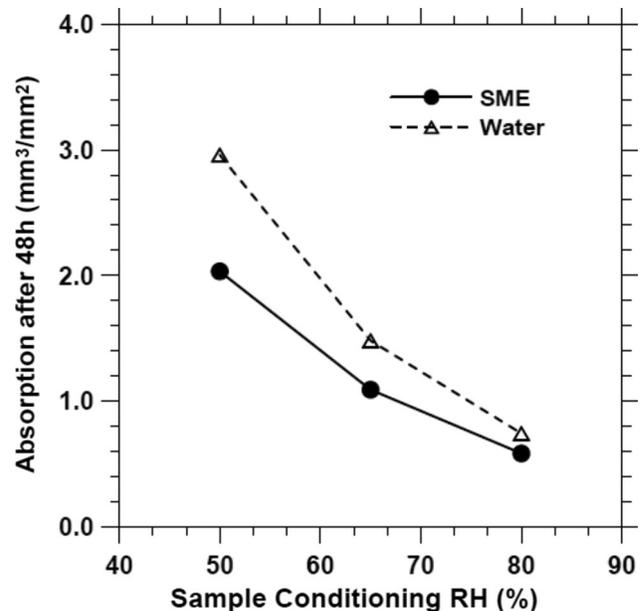
Figure 2.3 SME-PS and water absorption after 48 hours versus conditioning.

The ability of SME-PS to penetrate concrete depends on a few different factors. One such factor is the moisture content of the concrete. Samples were conditioned at $23 \pm 1^\circ\text{C}$ at different relative humidities for 18 months. Roughly 20 g of SME-PS were then ponded on the samples for 48 hours. Figure 2.3 shows the water and SME-PS absorption after conditioning at different relative humidities. It clearly shows that the SME-PS is highly dependent on the moisture content (Golias, 2010) however it is worth noting that a greater penetration depth is observed in a dry concrete. This implies that when the SME-PS is being investigated for use as a sealer it is better to dry the surface pores.

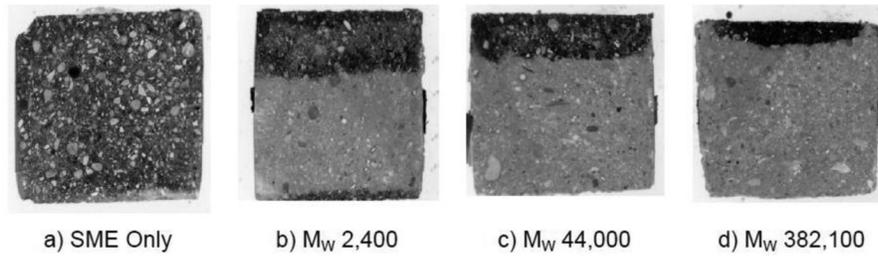
Figure 2.4 Penetration depth of SME-PS in black with varying PS chain lengths.

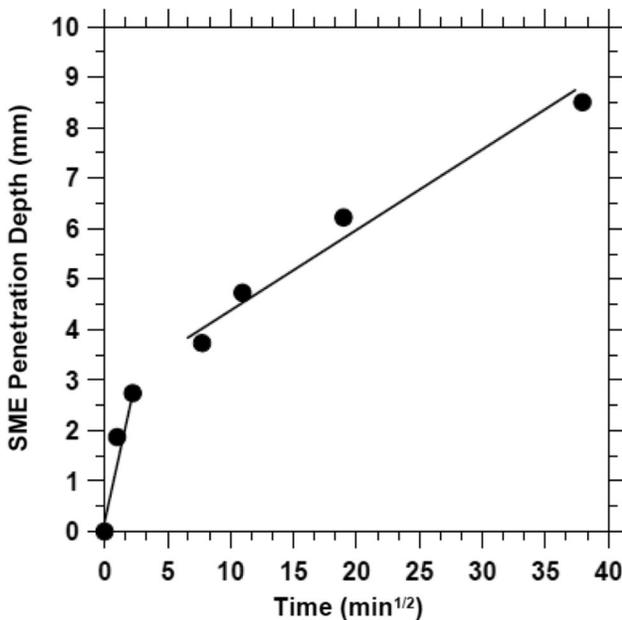
Figure 2.5 SME-PS penetration over time.

Time is the final factor that affects the SME-PS penetrability. Samples were submerged in SME-PS.

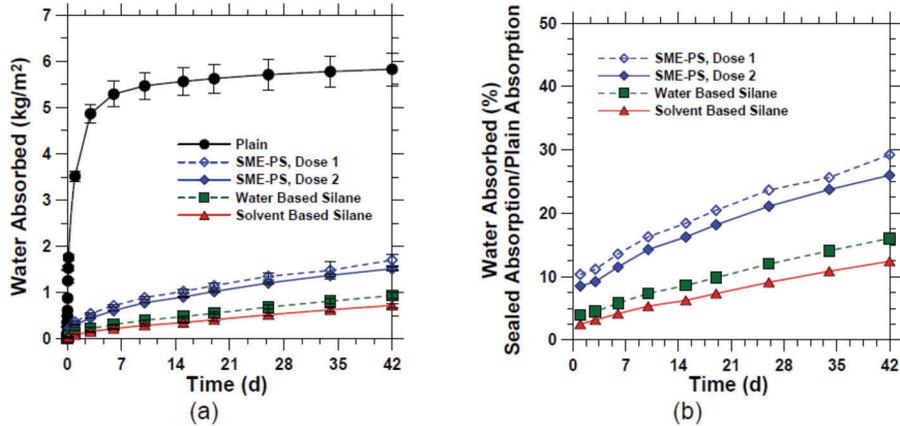
Figure 2.6 Water absorption where (a) is the amount absorbed and (b) is the percent reduction in absorption.

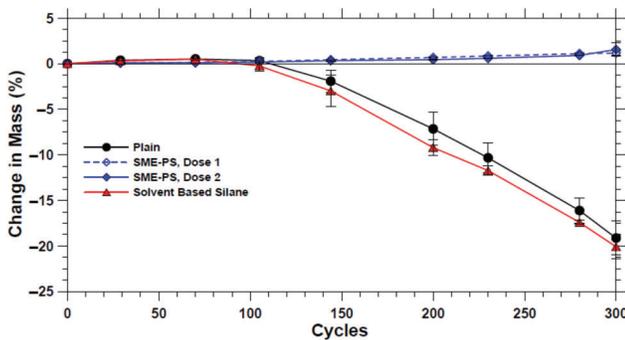
Figure 2.7 Mass change due to freezing and thawing.

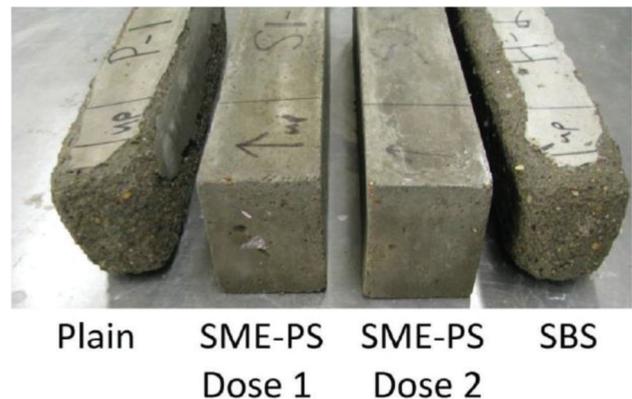
Figure 2.8 Samples after 280 cycles of freeze-thaw.

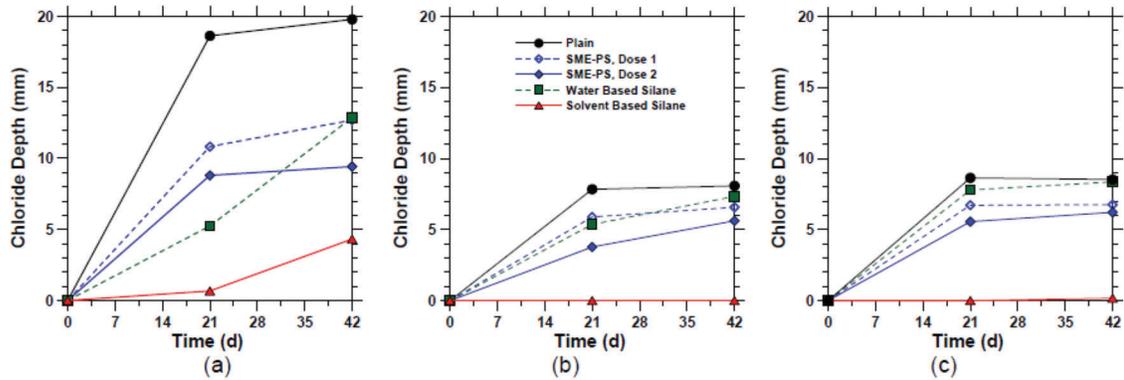
Figure 2.9 Chloride penetration depth for (a) sodium chloride, (b) magnesium chloride, and (c) calcium chloride.

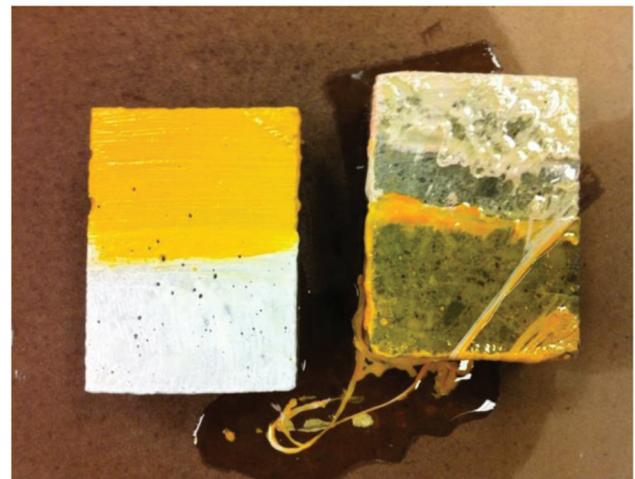
Figure 2.10 Tests of compatibility of SME-PS with INDOT road paint under normal exposure (left) and extreme exposure (right).

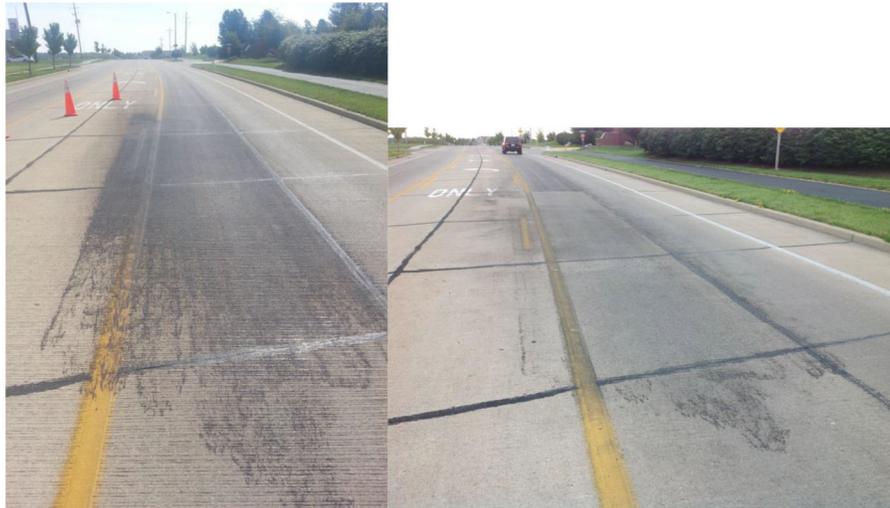
Figure 2.11 Asphalt spill on Kalberer Road before and after removal using SME-PS.

SME-PS is a solvent, which brings a few concerns with its use in the construction industry. This property can cause issues when SME-PS is being used in an area near asphalt or, less so, near paints. When exposed directly to asphalt and given a period of time the SME-PS will soften the asphalt, potentially up to a point where it can be removed with mechanical abrasion. This property has created both negative and positive situations. Although it can cause unwanted damage to asphalt that lies in areas near concrete pavements that are being treated, it can be beneficial when removing ineffective areas of asphalt overlay that had been used in an attempt to seal the joints or cracks.

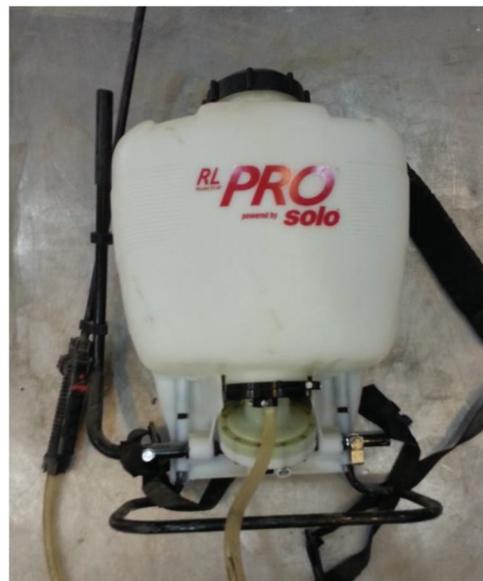
Figure 2.12 RL Pro Flo-Master backpack sprayer used in field application of SME-PS.

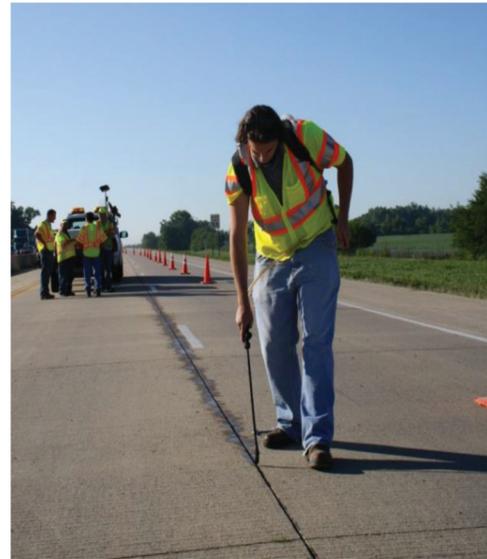
Figure 2.13 Demonstration of field application of SME-PS, on US-231 in Lafayette, IN.

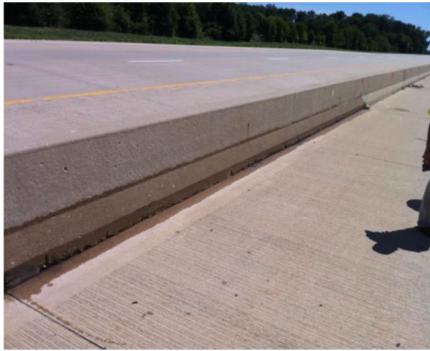
Figure 2.15 Treatment of the median barrier at the SME-PS test section on US-231.

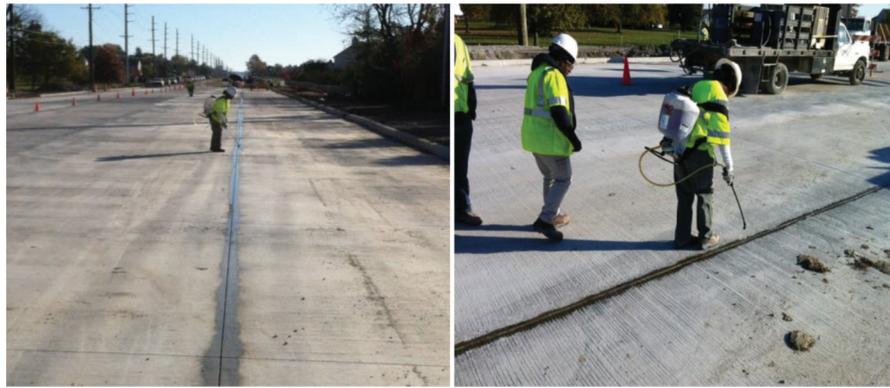
Figure 2.17 Application of SME-PS to 126th street in Fishers, IN being performed by members of Berns Construction.

Sealing of this section occurred on October 25, 2011 with the coordination of BFS Engineering and Berns Construction who were managing the construction project. Application was conducted by members of the Berns construction team per manufacturer’s specification as shown in Figure 2.17. After application,

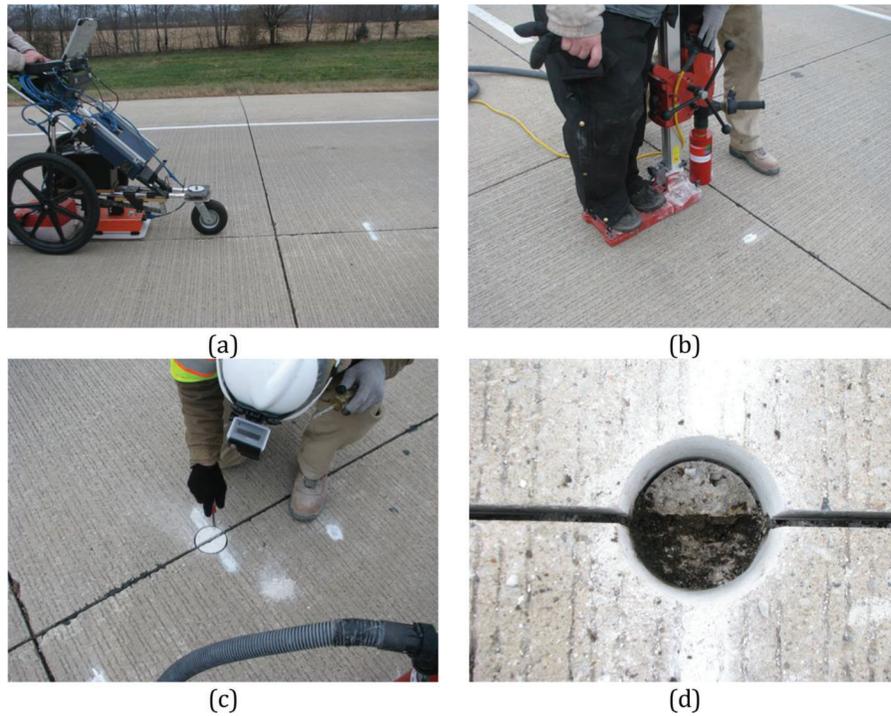
Figure 3.2 Coring process (typical for all coring locations): (a) location for core marked, (b) core drill drilling pavement at joint, (c) removing core from road, and (d) joint with core removed. Not seen is the core being filled in with hot mix asphalt.

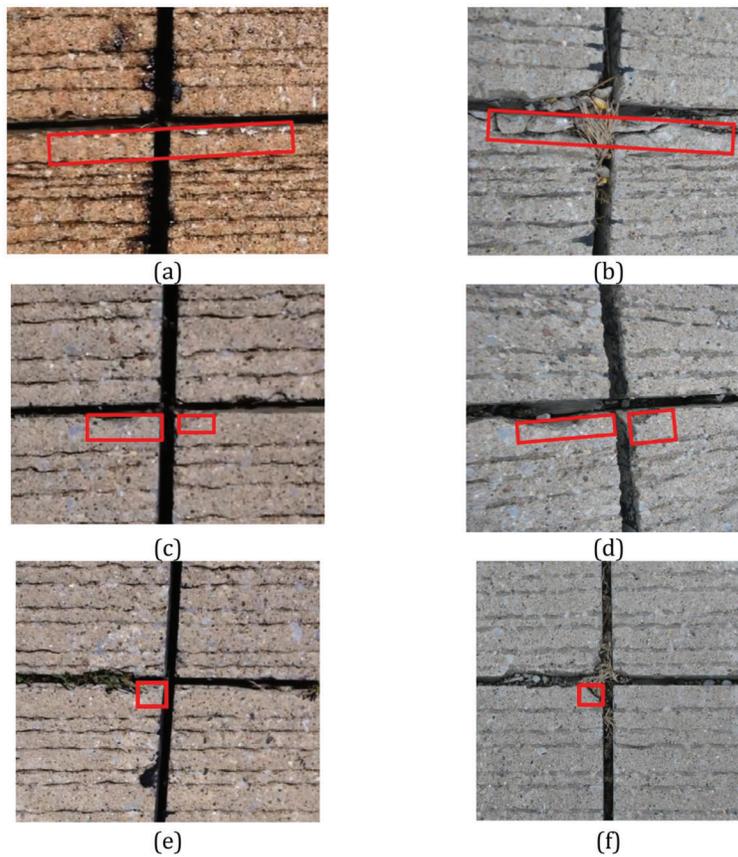
Figure 3.3 Before and after pictures of damaged locations: (a) slab A4-A5 before, (b) slab A4-A5 after, (c) slab C1-C2 before, (d) slab C1-C2 after, (e) slab C3-C4 before, and (f) slab C3-C4 after.

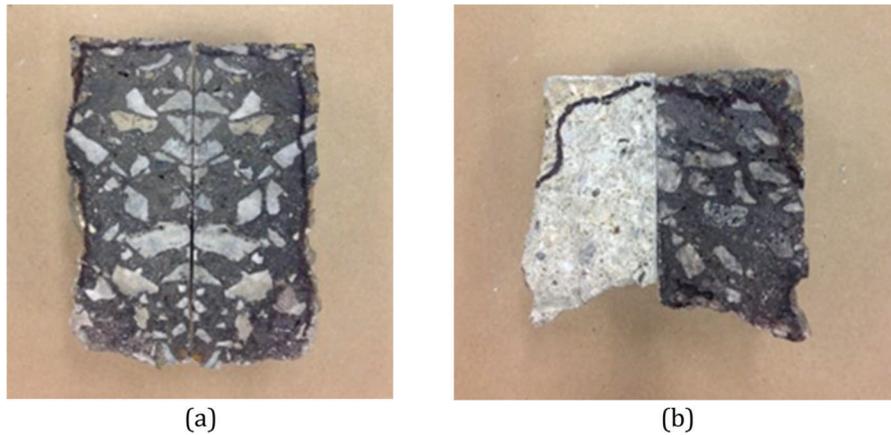
Figure 3.4 Cores split in half with silver nitrate applied. Sharpie mark indicates approximate depth of chloride penetration: (a) SME, (b) control.

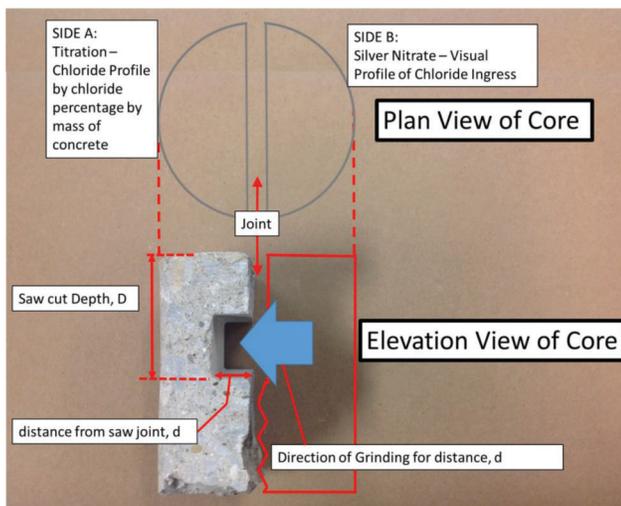
Figure 3.5 Elevation and plan view of core; one side of core used for titration, one side visually inspected for chloride ingress.

The other side of the core was tested for chloride ingress by the grinding and titration method. Powder was obtained by grinding the bottom of the surface of the saw cut with a diamond core bit (see Figure 3.5 and Figure 3.6). Taking titration measurements, thus obtaining a chloride profile perpendicular to the saw cut, allowed understanding of how the chlorides moved horizontally into the concrete from the side of the joint. The powder was taken at the depth, D, where the saw cut made the bottom of the joint. The measurement of distance from the vertical surface of the bottom of the

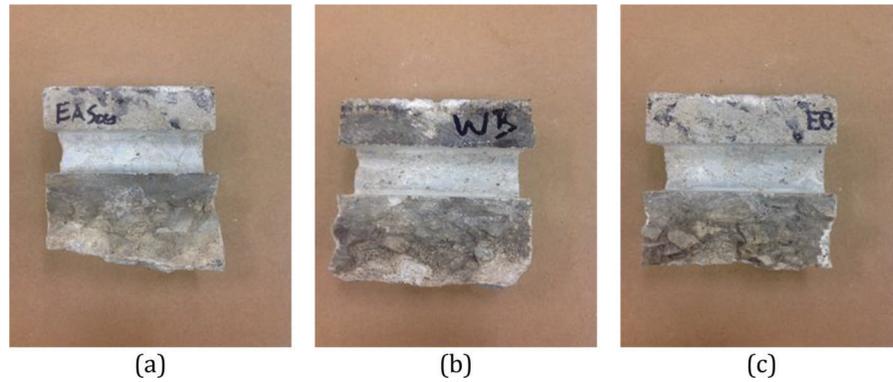
Figure 3.6 Titration side of 3 samples taken from US-231: (a) soy, (b) as-is, (c) control.

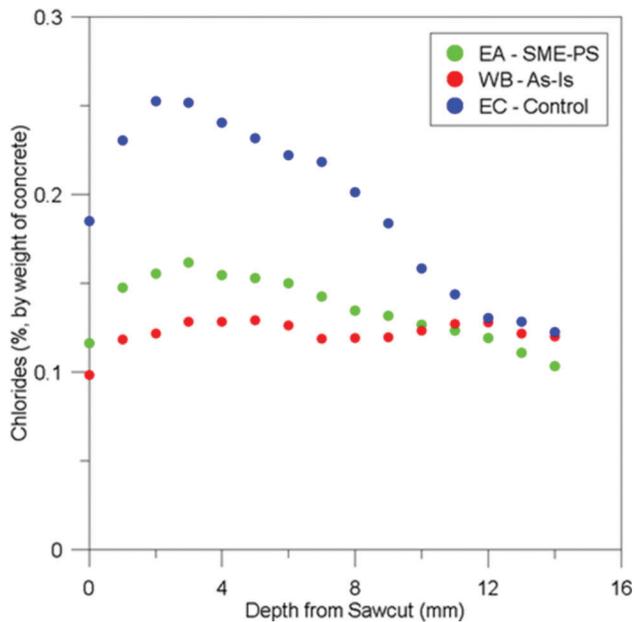
Figure 3.7 Chloride profile data obtained from titration machine.

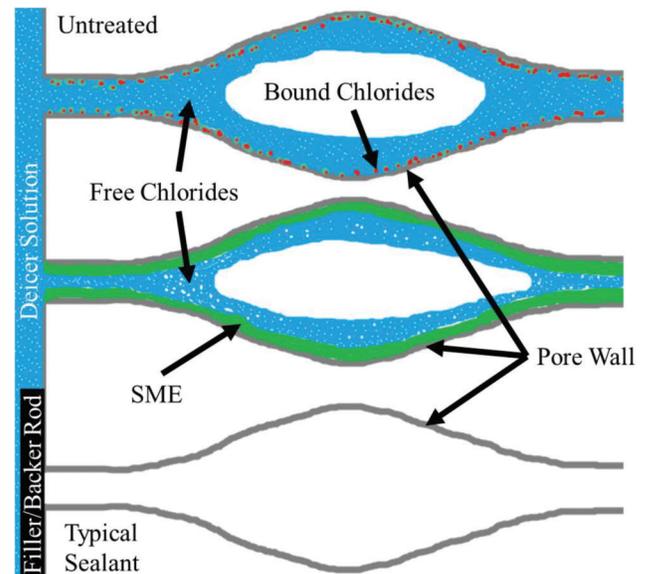
Figure 3.8 Simplified model showing the difference between an untreated sample, an SME treated sample, and a sample with a typical sealant like backer rod and filler. Untreated sample allows water and chlorides to enter pore (some of the free chlorides become bonded to the pore wall as they react with the pore wall). SME sample restricts full flow of deicer solution and keeps free chlorides from reacting with cementitious pore wall. Typical sealant keeps all water out assuming the sealer is untarnished and working properly.

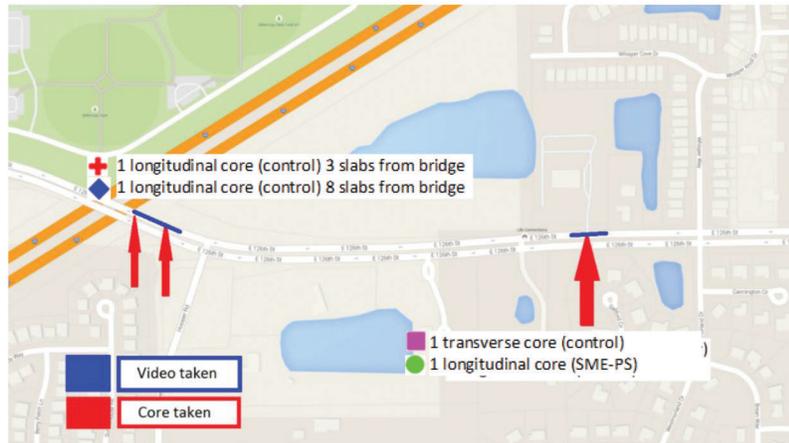
Figure 3.9 Location of samples taken on (a) December 9, 2014, and (b) March 17, 2015.

In total nine cores were taken from 126th street in Fishers (Figure 3.9). The sampling was spread between two sampling dates. During the first trip on December 9, 2014, five cores were taken and on a second trip on March 17, 2015, four more samples were taken. New videos were taken at both locations however in the previous documentation, there were few usable pictures or videos taken of the I-69 overpass. New video and photo records from the west bound lane just west of the overpass were taken and the location recorded for future site visits.

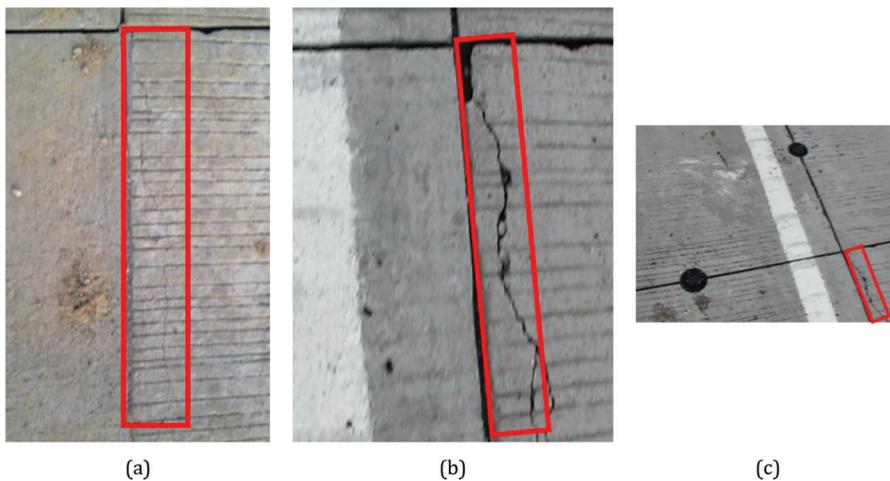
Figure 3.10 First location of longitudinal joint sampling of SME-PS samples: (a) 1 slab west of sampling location on the day of SME-PS application, (b) 1 slab west of sampling location on the day of coring, (c) overview of sampling location and visible crack.

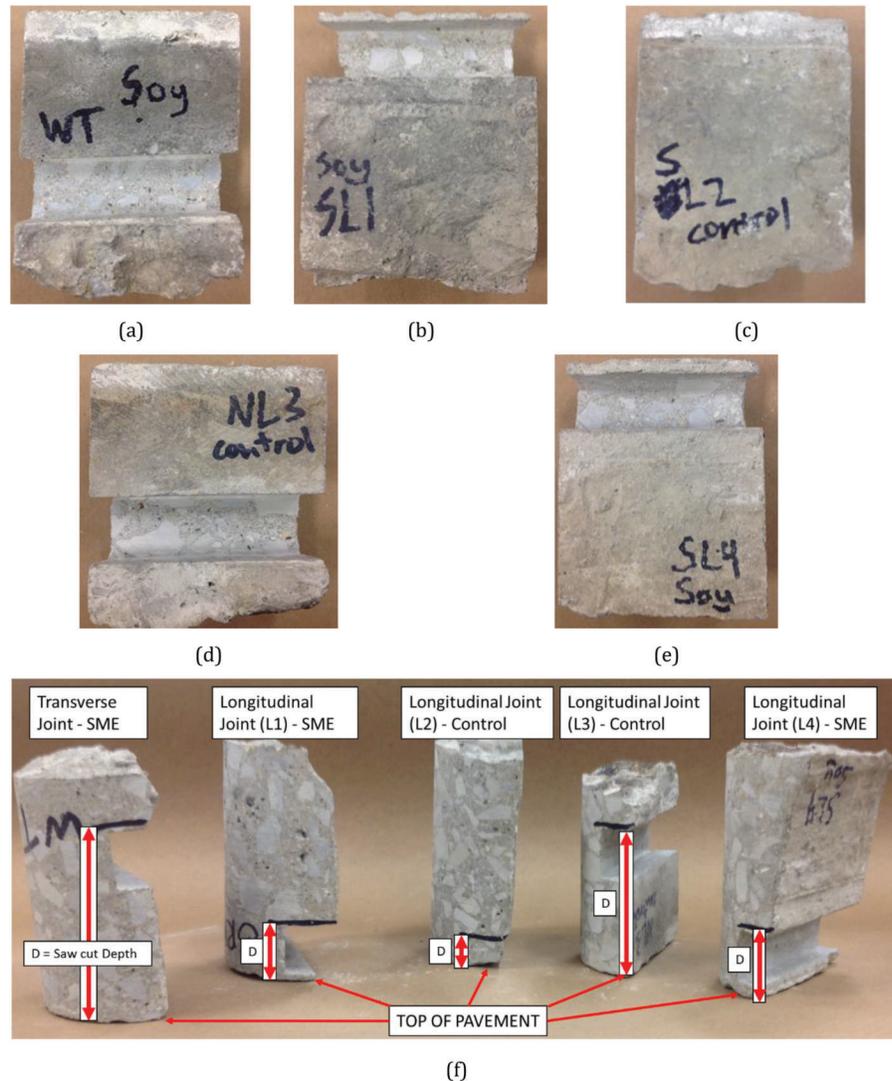
Figure 3.11 Titration side of 3 samples from Fishers: (a) transverse SME joint; (b) longitudinal SME joint, (c) longitudinal control joint; (d) unusable longitudinal joint (L3)—control; (e) longitudinal SME joint; and (f) titration side of 5 samples taken from Fishers in order from left to right—T, L1, L2, L3, L4, L5. Note: control depth of saw cut varies.

the inconsistent saw-cut depths. As seen in Figure 3.11 there is a range from half an inch to three inches from the five samples taken from the field. A change in saw joint depth can cause problems in the pavement by not localizing the crack into the saw joint which increases the chance that the crack forms elsewhere as seen in Figure 3.10. In the case of crack running alongside the longitudinal crack, this is most likely attributed to the fact that the saw cut was only one inch deep Figure 3.11 (b). This lack of depth may attribute to the crack and its growth seen in Figure 3.10. There is no crack parallel to the transverse joint and this may be due to the saw-cut depth being adequate as seen in Figure 3.11 (a).

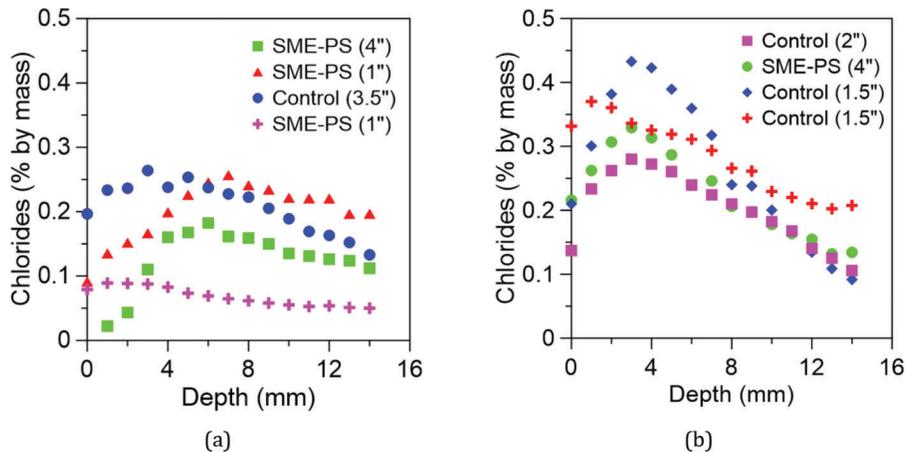
Figure 3.12 Chloride profile results (depth from top surface in parenthesis) taken in (a) December 9, 2014, and (b) March 17, 2015.

In Figure 3.12 (a), the two SME samples denoted by a green square and red triangle are two cores from the same slab but at different joints, the first in the transverse joint and the second in the longitudinal joint. The sample with a one-inch saw cut has higher chlorides than the sample adjacent to it likely because the chlorides from the surface are being measured rather than only the chlorides coming in from the horizontal direction.

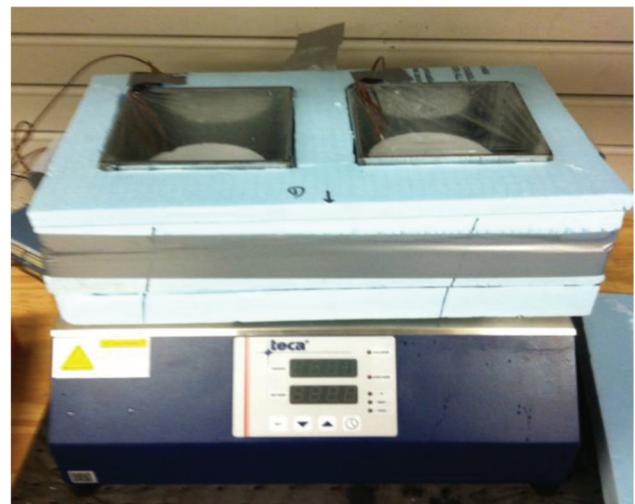
Figure 4.1 Schematic of experimental setup for freeze-thaw absorption with chloride solution.

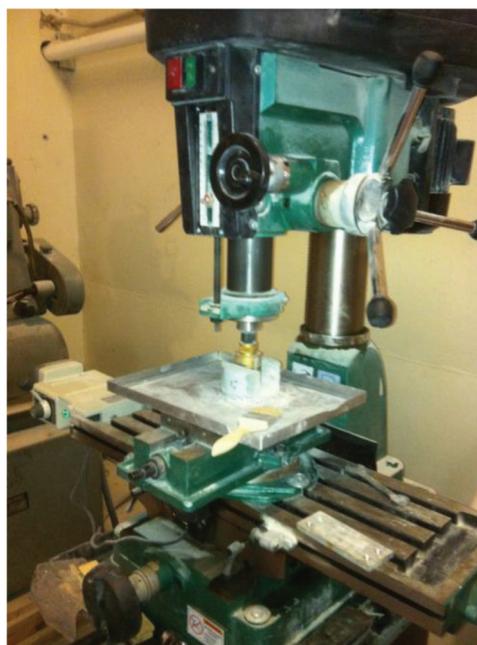
Figure 4.2 Surface grinding used to obtain powder for titration.

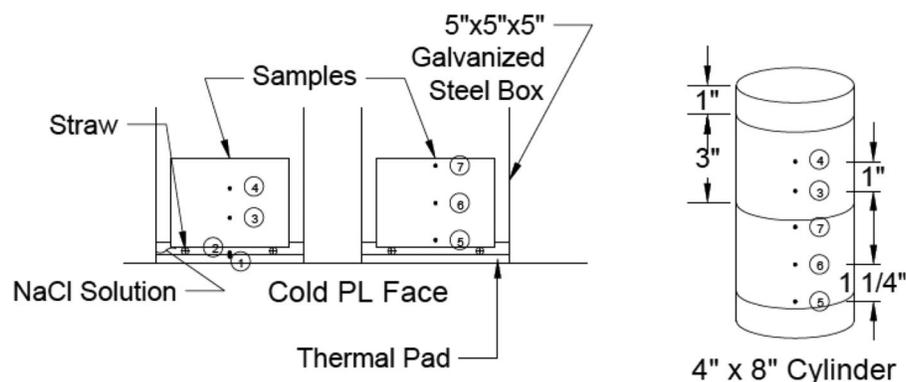
Figure 4.3 Section view of the test setup (left) and the locations of the thermocouple wiring in the cylinder (right).

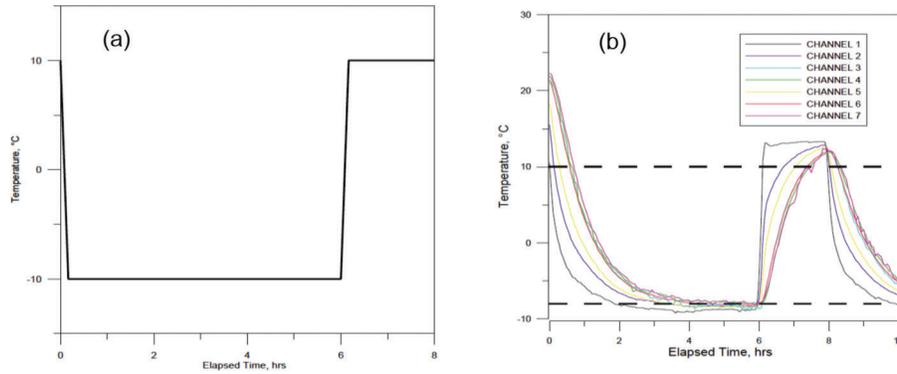
Figure 4.4 (a) Cycling of cold plate for temperature testing and (b) temperature output used to determine cycle lengths.

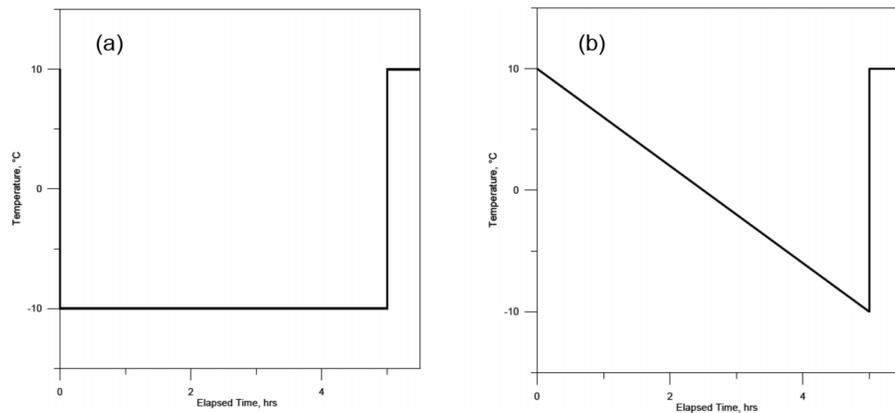
Figure 4.5 Cycling for determination of the freezing rate (a) shows “quick” loading and (b) shows “slow” loading.

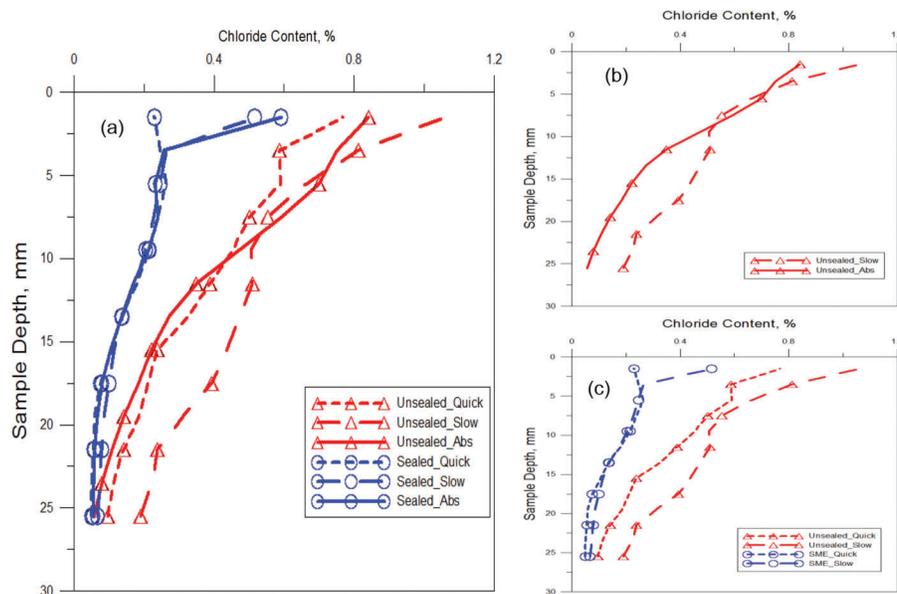
Figure 4.6 (a) Compares chloride concentration for sealed and unsealed samples at different loading rates, (b) demonstrates chloride pumping, and (c) is evidence that “slow” loading causes a higher concentration of chlorides further into the sample than quick loading.

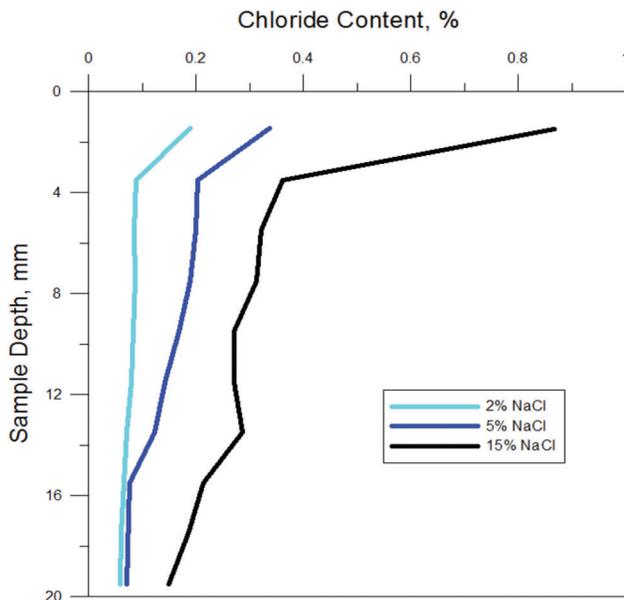
Figure 4.7 Chloride profile for solutions containing 2%, 5%, and 15% NaCl by mass.

This round of testing was used to determine the concentration of sodium chloride to be used in the standard testing procedure. The plot seen in Figure 4.7 shows that as the concentration of the solution increases, the chloride content throughout the sample increases. Although a lower concentration could theoretically penetrate further into the sample due to slightly lower viscosity, this was not seen here. For the purposes of our testing, a nearly saturated sodium chloride solution was used. This is not to say that other chloride solutions and concentrations couldn't be considered, however further

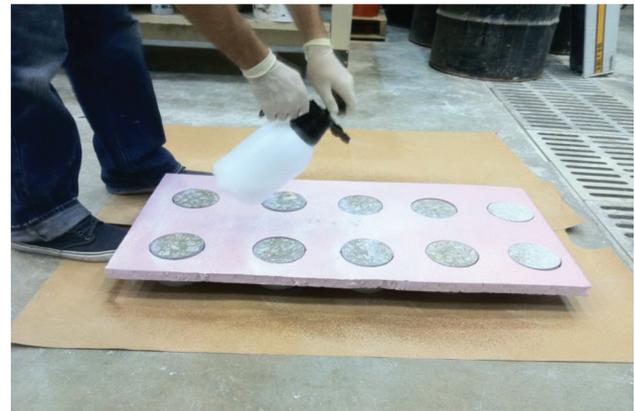
Figure 4.8 Uniform application of sealants to cylindrical concrete samples.

Application rate plays a role in the effectiveness of the sealant. Aside from the use of the flat-board, a light sprayer was used to apply each of the sealants. Each sealer was applied using an application rate of 125 ft²/gal, which fell within each manufacturer's recommendation for concrete applications.

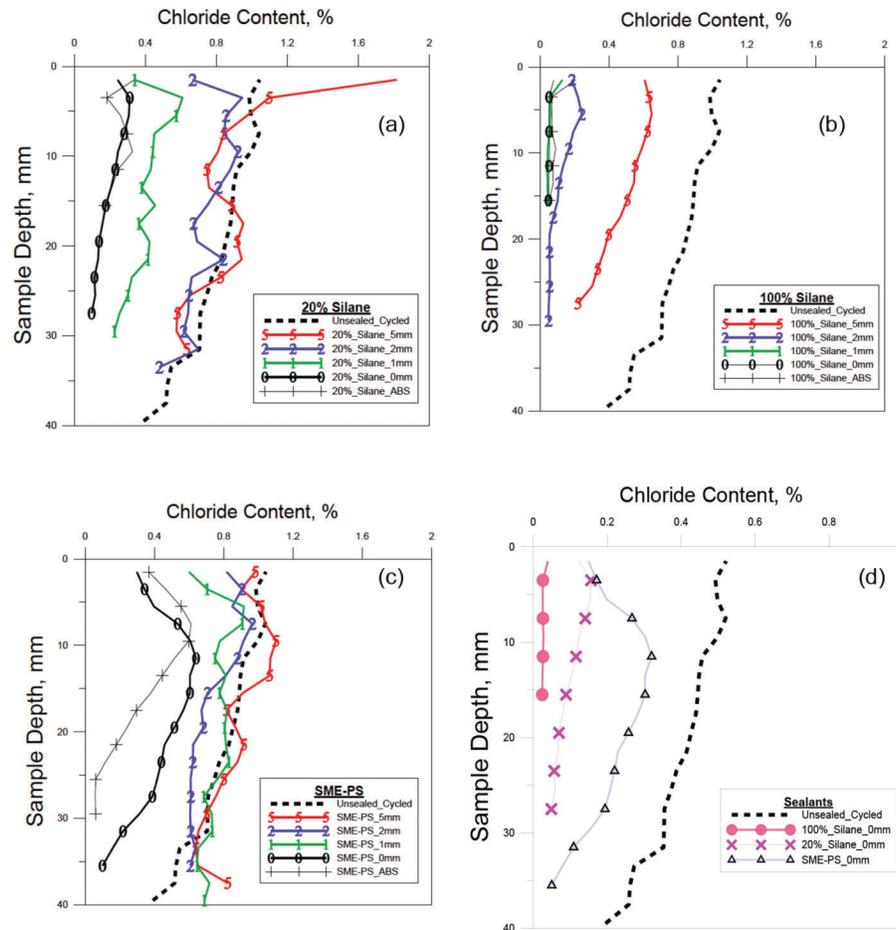
Figure 4.9 (a) Chloride profile for the 20% silane sealant used in this study, (b) chloride profile for the 100% silane sealant used in this study, (c) chloride profile for SME-PS (5% by mass) sealant used in this study, and (d) summary showing all three sealants without removal of the top surface.

Figure 4.9 (d) shows a plot of all three sealants with the originally sealed surface. It can easily be determined which sealants performed best for this particular test. All three sealants prevented chlorides from being absorbed into the sample.

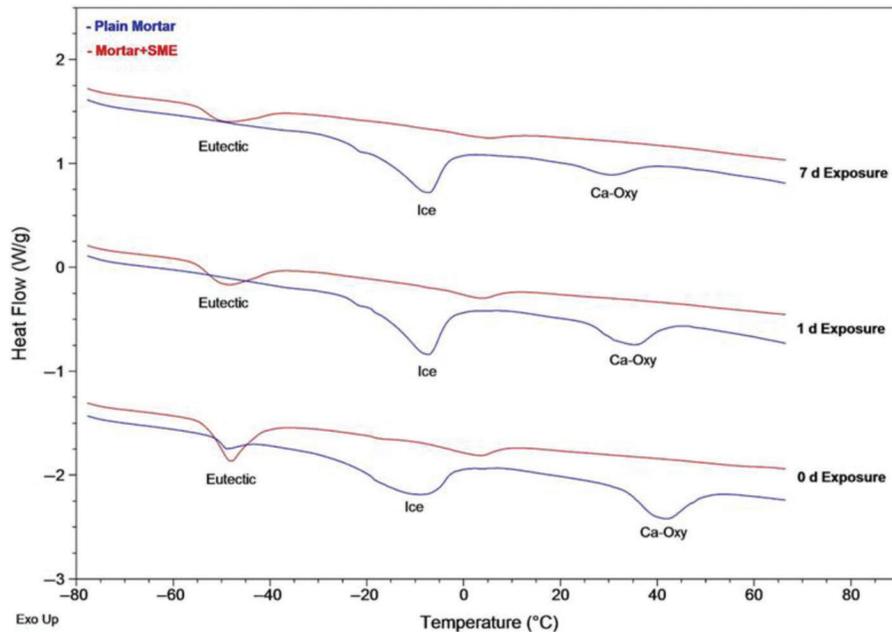
Figure 5.1 Low temperature differential scanning calorimetry (LT-DSC) for plain mortar sample and mortar sample with SME at different exposure times to 29.8% CaCl₂ solution (calcium oxychloride is shown as Ca-Oxy in the figure).
